Investigation of Cold Cathodes
for
Long Life CO₂ Waveguide Lasers

Final Report
for Contract F49620-79-C-0076

U. Hochuli

November 1981

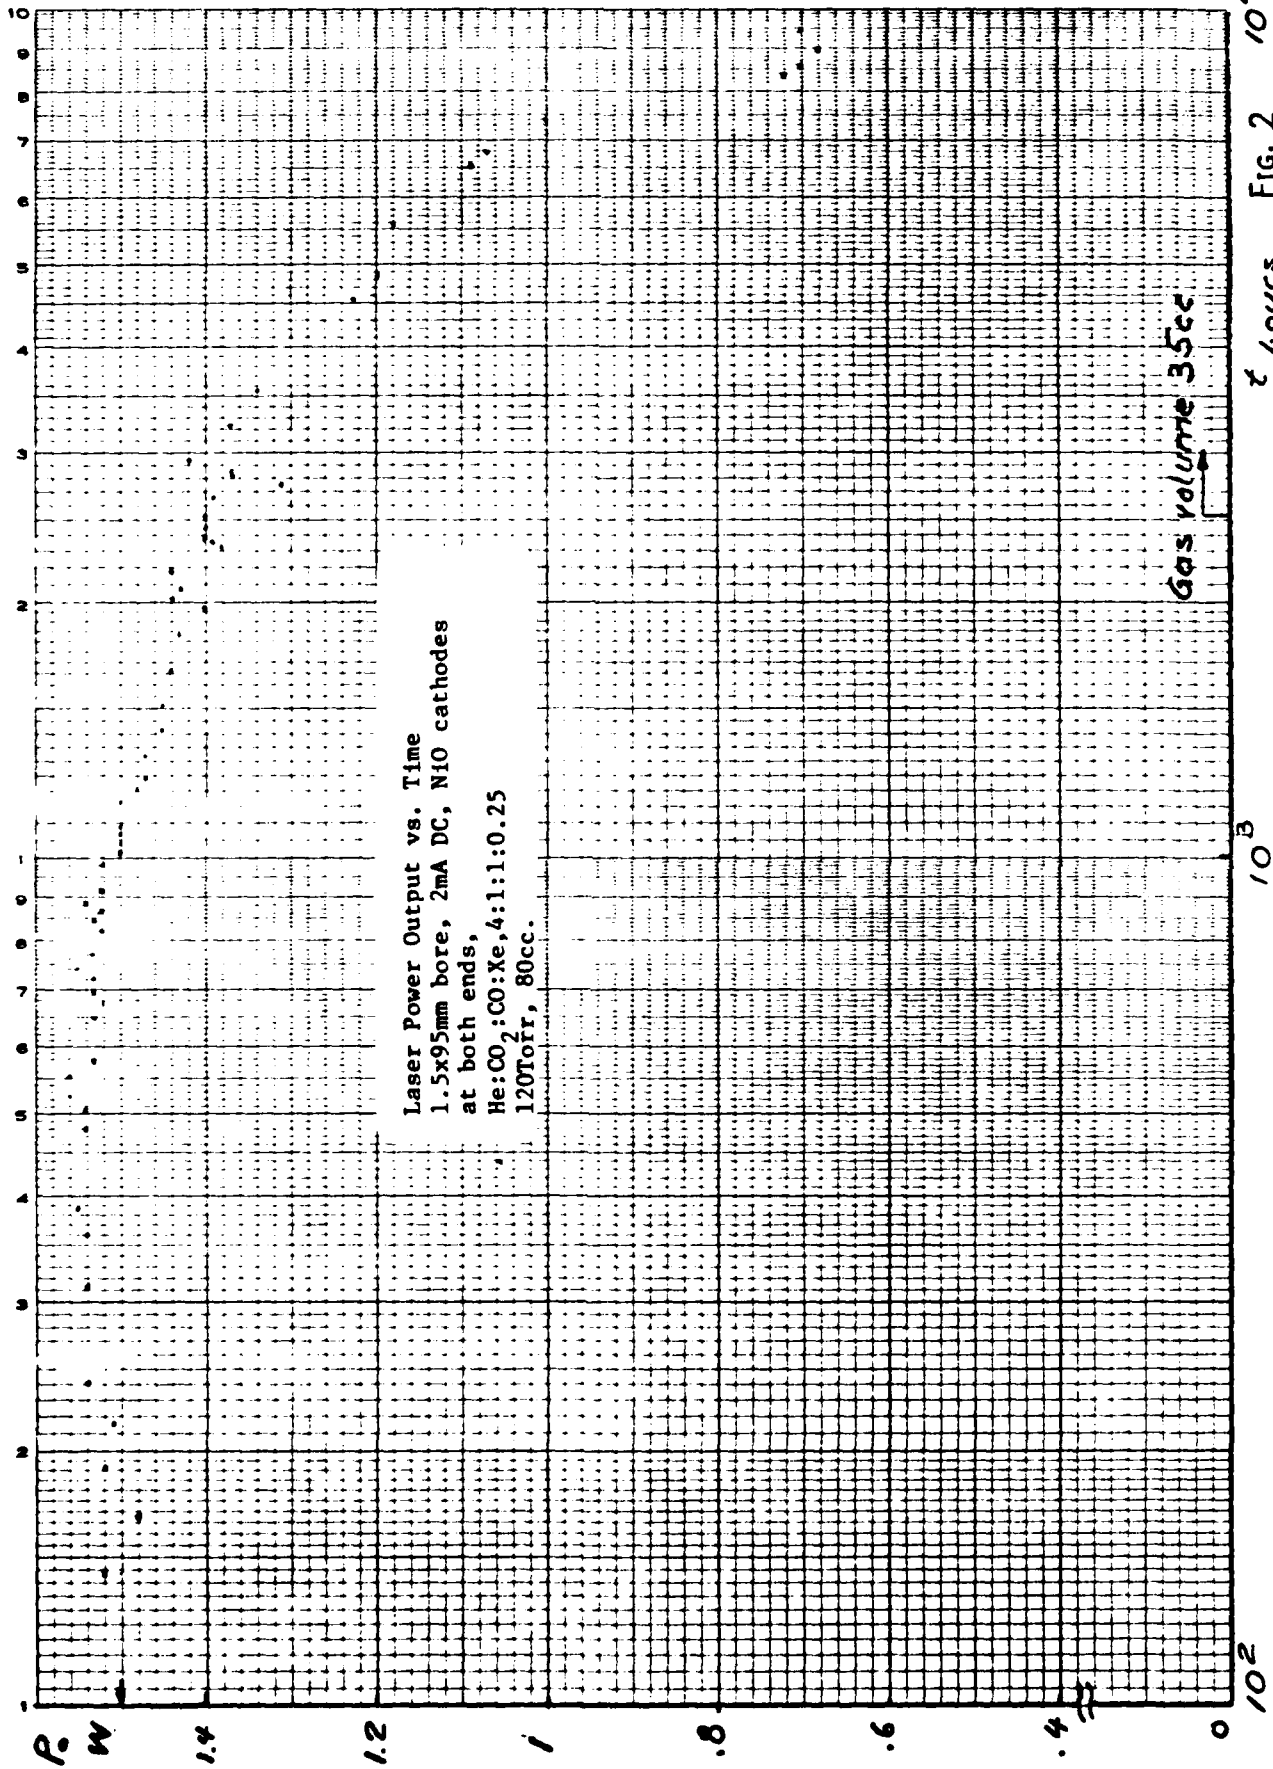
FIG. 2 10⁴
t hours

As Figure 2 shows the power output of this laser decreased from 1.54W to 0.7W after 9500 hours. Evacuation to 1 Torr and refilling restored the power to only 0.86W. Vacuum pumping and 100°C heating for two days, followed by refilling, restored the output power to 0.9W. Our laser structures use external windows (uncoated ZnSe, tilted 7° to avoid retroreflections) as vacuum seals behind the internal mirrors. Power supply failure over one weekend lowered the laser body temperature to the 15°C cooling water temperature.

Humidity had condensed on these windows and together with the dust and the grime formed water spots. A cotton swab and alcohol treatment could not remove these spots. At the time we thought that this visual degradation would not absorb much power at 10.6μ . Repolishing these windows, on the laser, with Linde type A and B Al_2O_3 polishing compound improved the laser power output to 1.34W. Replacement of two additional mirrors (front surface Al coated, used for deflection of power from both laser ends onto power meter) further increased the power meter reading to 1.4W. This value is within 10% of the original 1.54W and is an indication that no serious mirror damage had occurred. Removal of the laser mirrors revealed the central 1.5mm area either by breathing on it or by noticing a very faint greenish hue through observation of the surface at a glancing angle. Very few specks of black NiO with diameters of 10 to 30 microns could be seen in the BeO cathode cavities. The Al_2O_3 sputter shields also had a light black color in the central hole and the color gradually thinned out into a very light greenish hue over most of its front surface. This greenish hue did not seem to extend into the cathode cavity of the BeO body.

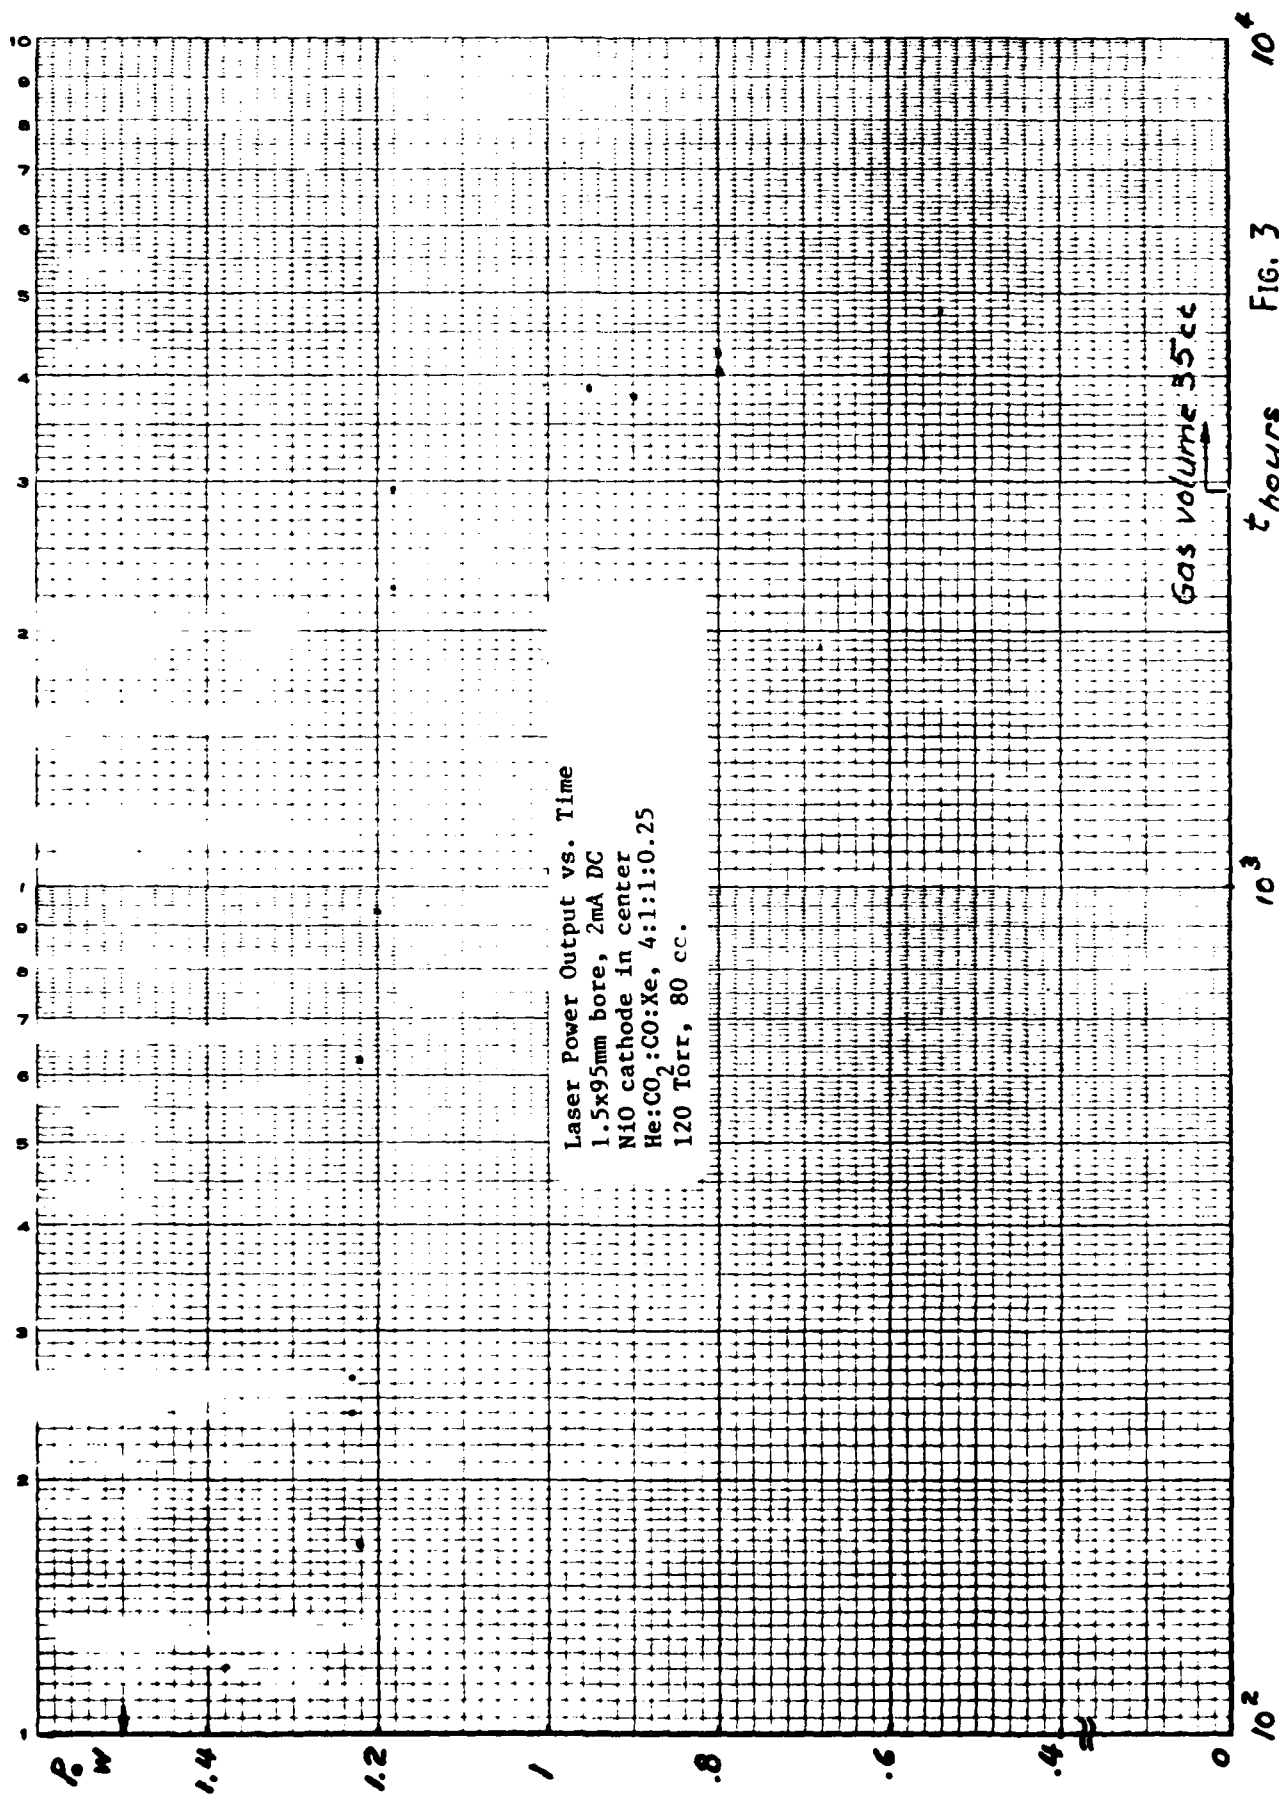
FIG. 3

Figure 3 indicates a power drop from an initial 1.5W to 0.54W after 4750 hours. Increasing the gas volume again to 80cc, by reconnecting the laser to the same gas supply

that was used for the first 2900 hours, raised the output power to 1.2W. Pumping down to 1 Torr and refilling the laser with new gas increased its power output to 1.4W compared to 1.5W for the new laser. This indicates that no serious mirror damage had occurred. The laser was then carefully evacuated with the Vac-Ion pump and outgassed for two days at 100°C. Refilling and measuring the power output gave 1.39W or essentially the same as before. 1300 hours later this output was down to 0.68W, almost as before. Leak testing revealed a small leak through the once repaired crack in the BeO structure. This leak was most likely caused by the previous 100°C heating cycle.

Opening the structure revealed a crater like, metallic looking, material build-up around the center hole in the cathode sputter shield. This deposit turned out to be Ni originating from the sputtered, reduced NiO of the cathode. The cathode cavity in the BeO body contained about 20 flakes in sizes ranging from 10 to 50 microns in diameter. About half of them appeared metallic and were magnetic and the rest looked like black NiO. X-ray fluorescence analysis confirmed Ni as the dominant composition of the flakes.
